Manhole Inspection Summary

Manhole # S41G2_004MH

Insp Date: **1/2/08 7:54 AM**

Location Address: **4201 6th St**

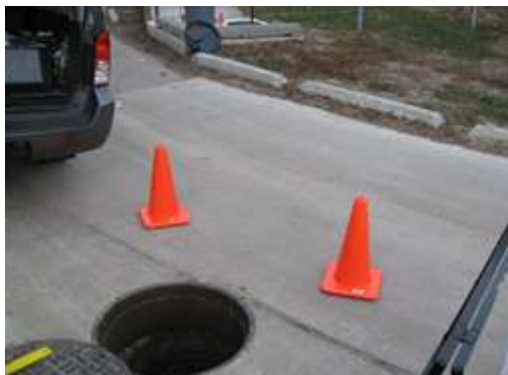
Location View

West Bay Ct

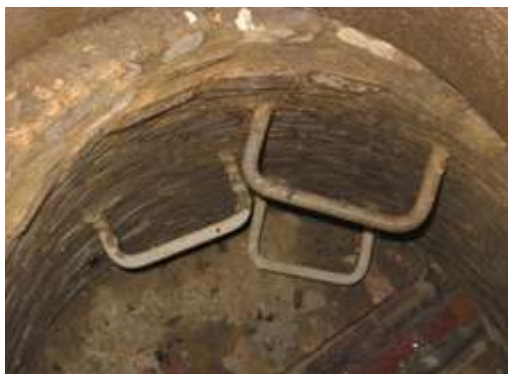
steps

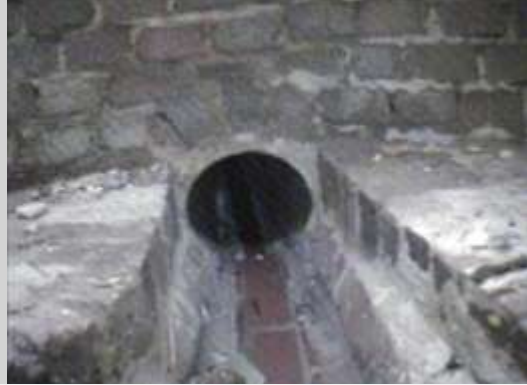
12 O'Clock Outflow

8 in. Circular Gravity Sewer
Pipe Out @ 12 O'Clock

Pipe Height: **8.4** (in.) Rod and Bar (Angled)
Pipe Material: **DIP/CI** ☐ Pipe Lined
Invert Depth: **7.66** (ft.) Flow Characteristics: **Slow**
Deposits: ☒ None ☐ Mud ☐ Sludge ☐ Debris ☐ Grease
Silt Depth: (in.) Deposits Extent:
Infiltration: **None** Pipe Seal Cond: **Sound**

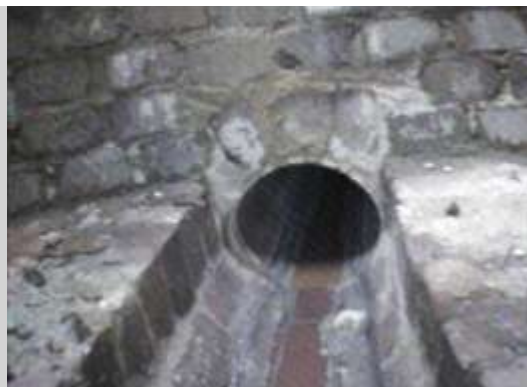
8 O'Clock Inflow

8 in. Circular Service Sewer
Pipe In @ 8 O'Clock

Pipe Height: **8.4** (in.) Rod and Bar (Angled)
Pipe Material: **DIP/CI** ☐ Pipe Lined
Invert Depth: **7.52** (ft.) Flow Characteristics: **Slow**
Deposits: ☒ None ☐ Mud ☐ Sludge ☐ Debris ☐ Grease
Silt Depth: (in.) Deposits Extent:
Infiltration: **None** Pipe Seal Cond: **Sound**
